# PV Module Quality Assurance Toolbox

PV ModuleTech 2026

**kiwa**

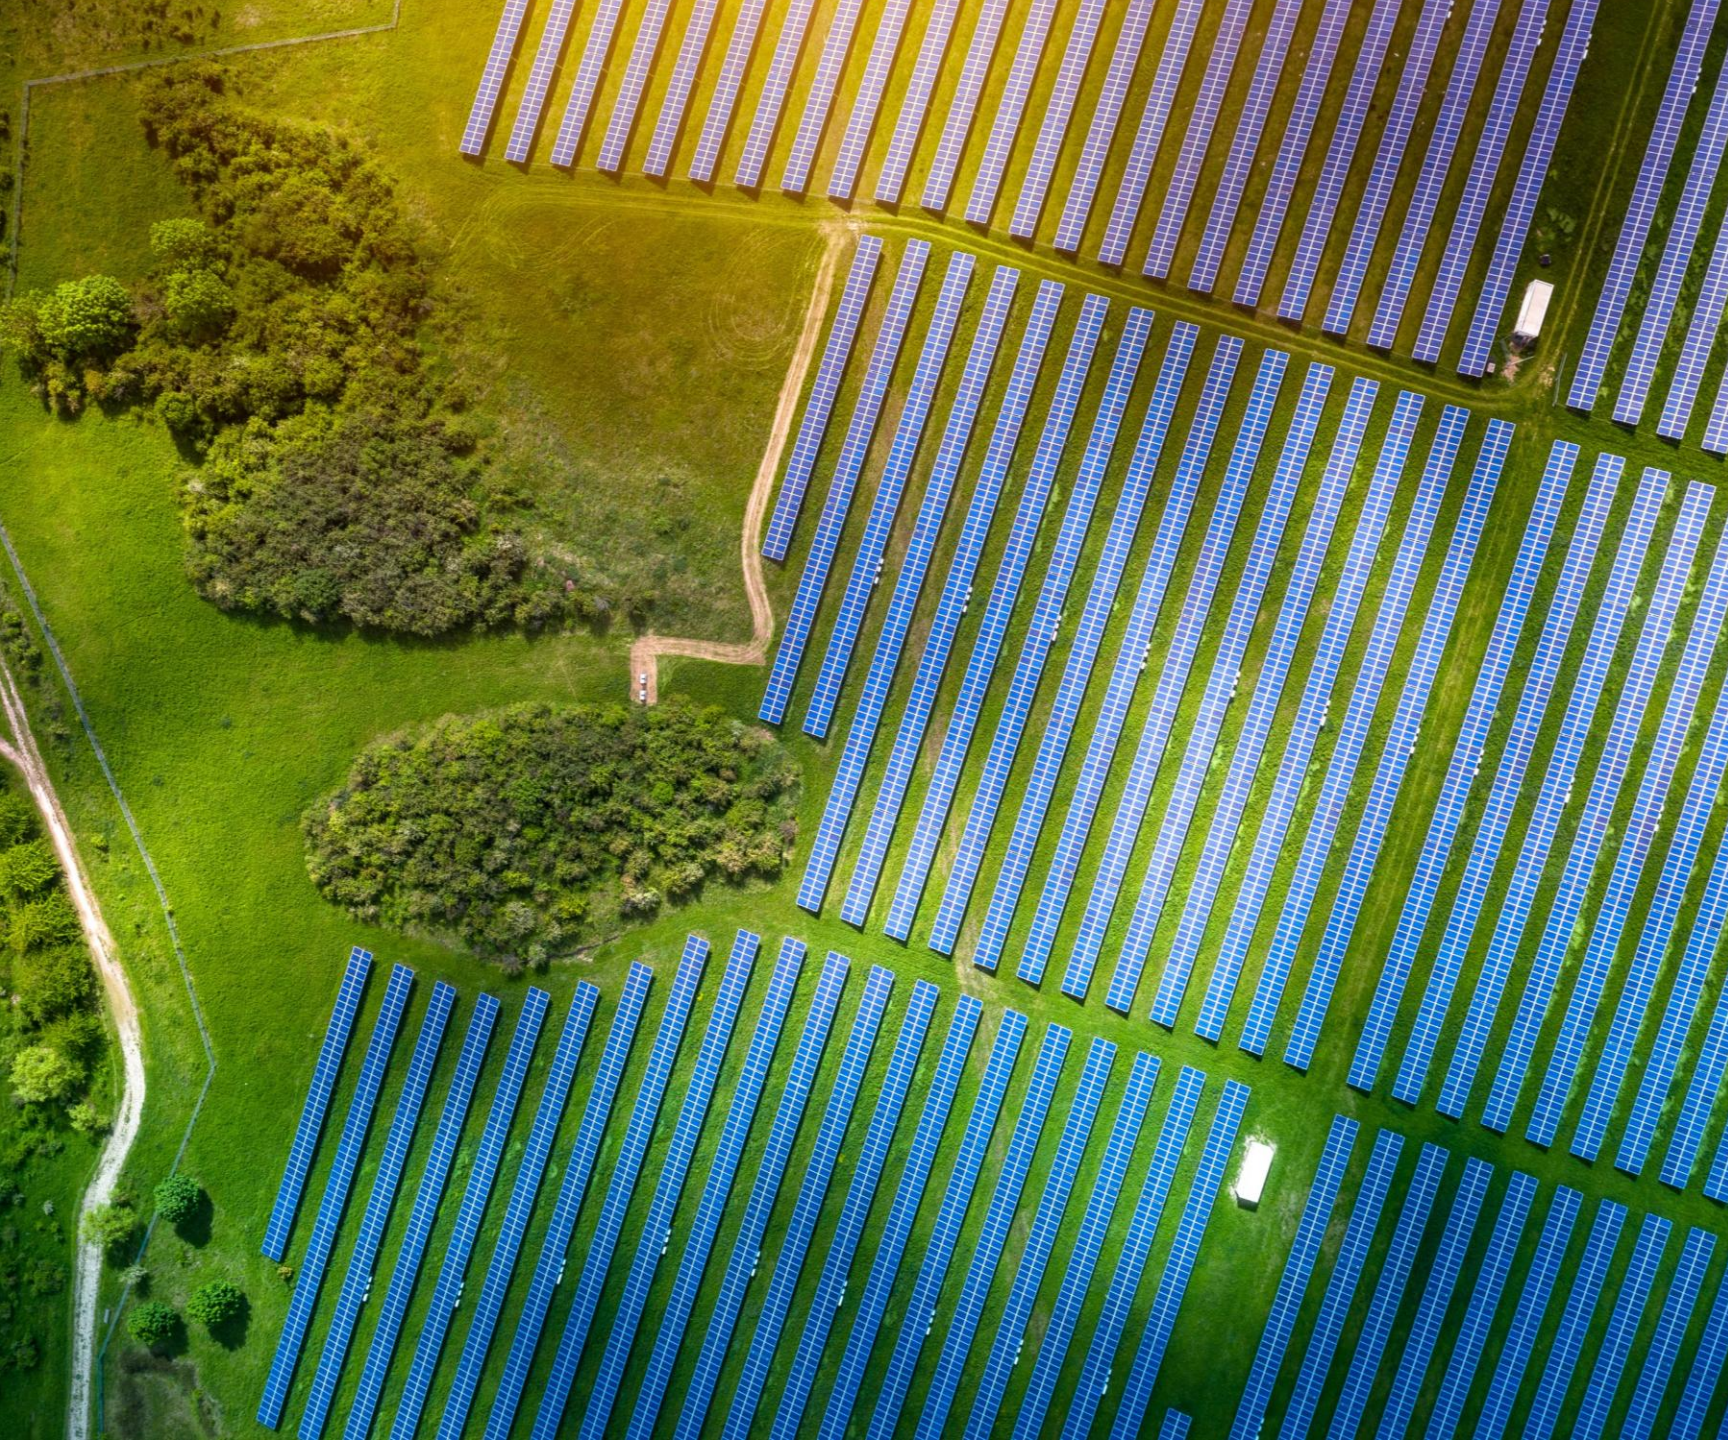
PSI Defect Distribution

- Over the last year, **Kiwa PI Berlin performed PSI on nearly 160,000 PV modules** across 65 global manufacturing facilities.
- Inspections followed contractually agreed to criteria, with defects evaluated against AQL requirements.
- End-of-line data showed greatest defects came from lamination, cell/string interconnect, cells, frame, and glass-related issues.

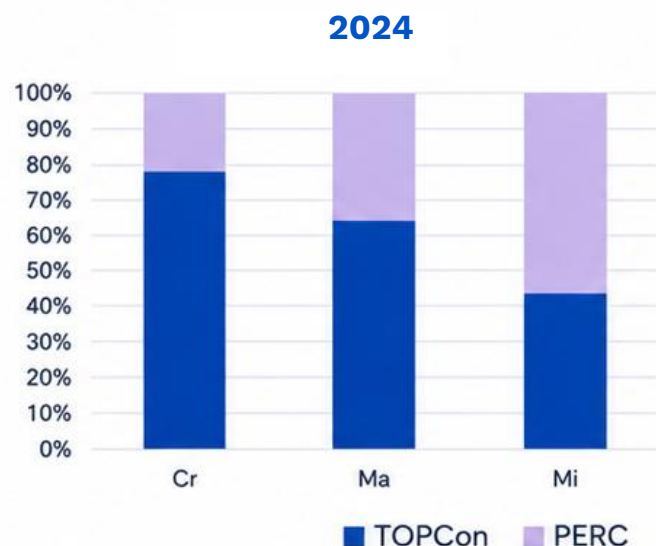
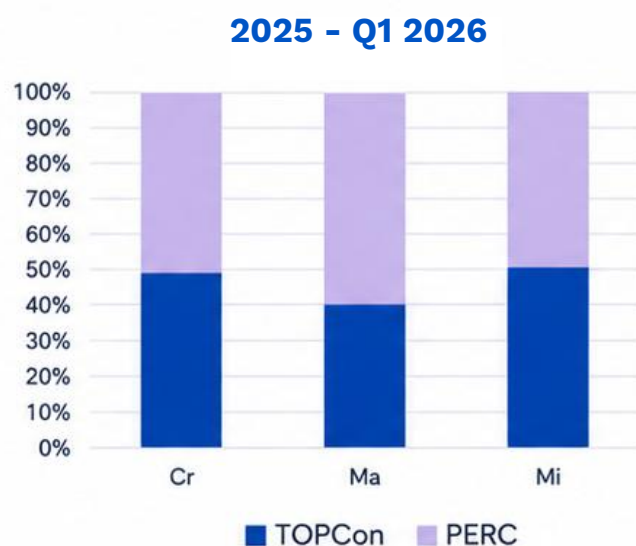
Another positive trend has been the reduction of **TOPCon-related findings** during production oversight compared with the prior year, when TOPCon showed higher **Major** and **Critical** defect rates versus **PERC**.

Findings have now leveled into a more balanced distribution between technologies, allowing buyers to apply similar QA coverage, quality requirements, and inspection plans without requiring heightened **TOPCon-specific** controls.

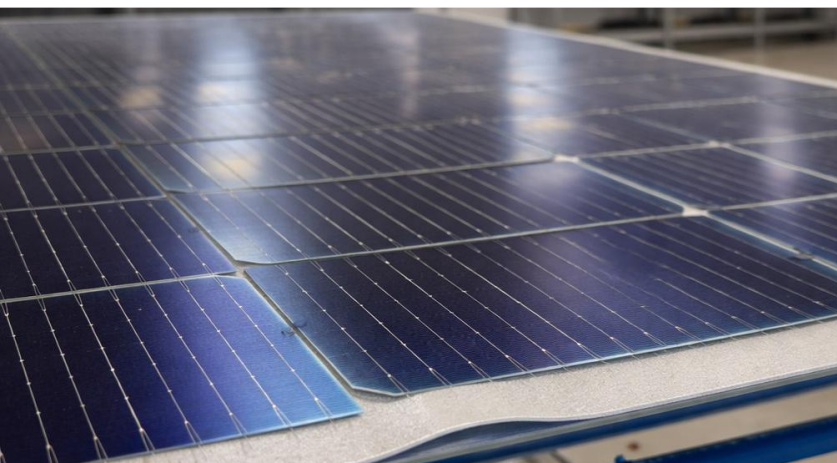
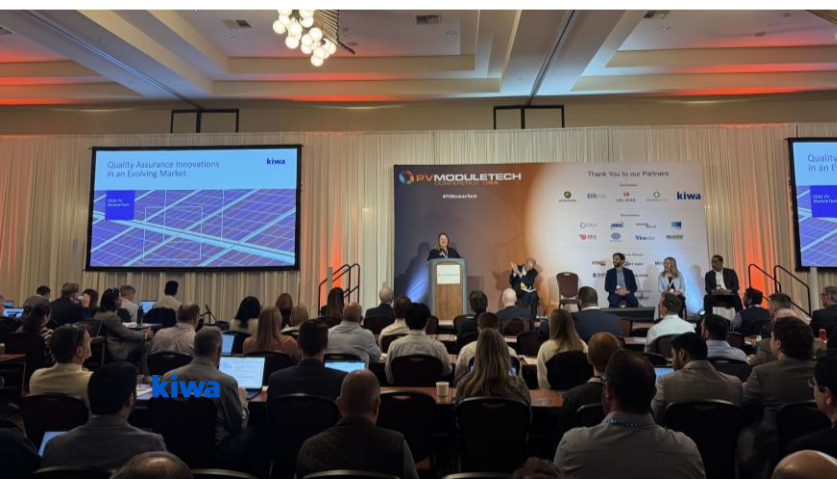
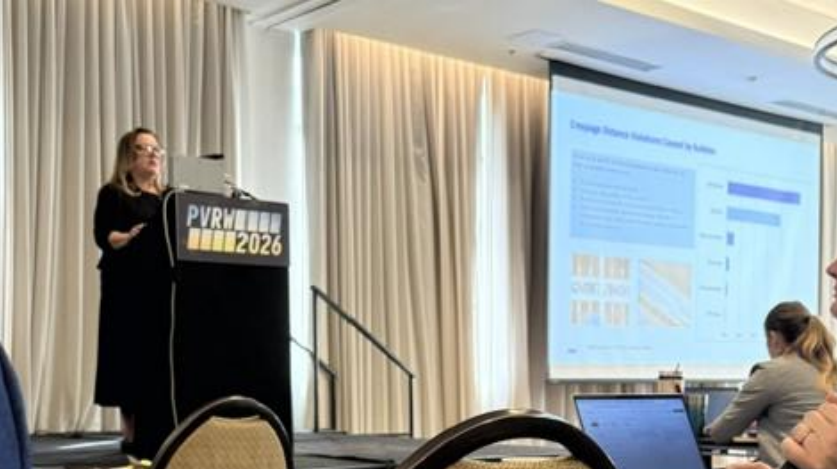
**Cell-to-Cell Spacing**

**The short circuit caused by cell-to-cell contact led to a hot spot and failure.**

Inadequate control of cell-to-cell spacing during production.

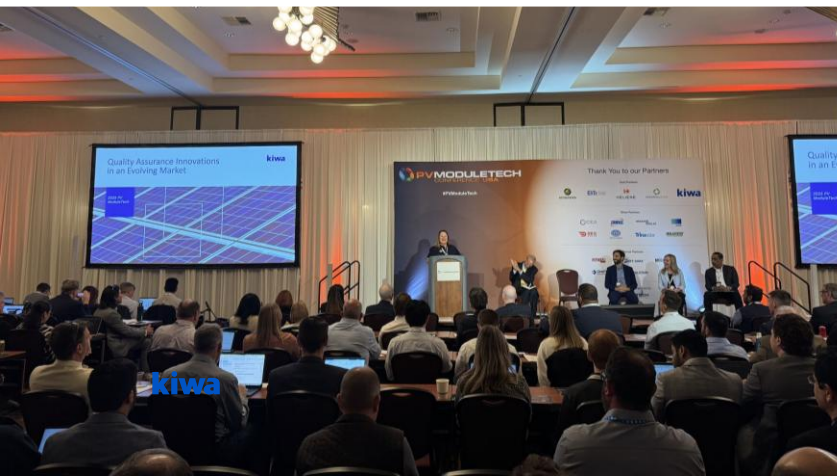
# Creepage Distance Defects

- With larger cells, manufacturers minimized inactive areas to maximize the efficiency.
- Tight spacing design without minimal tolerance allowances
- Equipment calibration often needs increased frequency
- Inadequate inspection criteria and screening- it **can** be identified in factory.
- [kiwa.com/2026pvmfrreport](https://www.kiwa.com/2026pvmfrreport)
